Protecting a Building Foundation Next to an Excavation Site

A general contracting company working on an excavation job for a new sea turtle habitat at Loggerhead Marinelife Center in Juno Beach, Florida needed specialists to protect the foundation of the adjacent building from potential destabilization. Underground Services of America was called in to create a polyurethane grout wall for this very purpose.

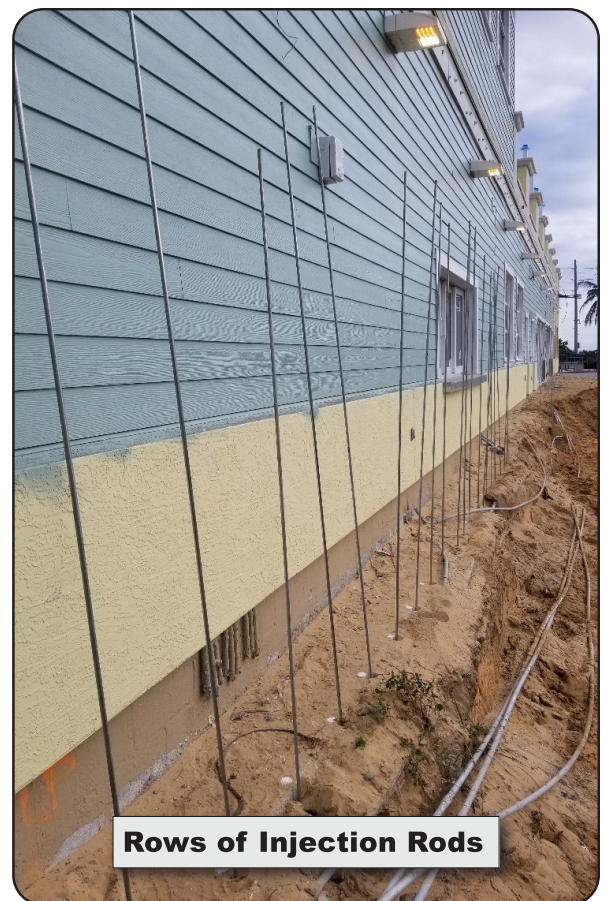
Underground Services of America professionals drove injection rods into the ground next to the building foundation in a staggered pattern (see photo). The rods were 18 inches apart from each other to ensure consistent, thorough permeation of the soil with the high-strength grout. They injected at a rate of one gallon per foot. A total of 500 gallons was used to form the grout wall. The project was completed in just two days.

The crew used AP Soil 600, a single component, moisture activated, hydrophobic, extra-low viscosity, polyurethane soil grout. This is the premier product for stabilizing soil via permeation grouting. It's also NSF-approved for contact with drinking water. Using an environmentally safe repair material in a marine habitat is extremely important.

The resin was cured within 24 hours of completion. The job was finished on a Friday. On the following Monday, the GC began excavation on the future sea turtle habitat without any fear of damaging the adjacent foundation.
